Manhole Inspection Summary

Manhole # S17II_016MH

Insp Date: **6/12/07 9:39 AM**

Location Address: **2201 PRESBURY ST**

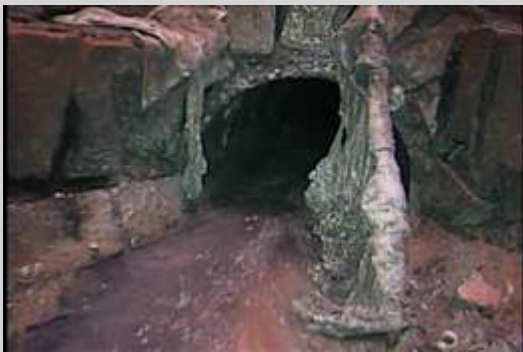
12 O'Clock Outflow

Pipe Height: **8.4** (in.) Rod and Bar (Angled)
Pipe Material: **Clay** ☐ Pipe Lined
Invert Depth: **10.36** (ft.) Flow Characteristics: **Slow**
Deposits: ☒ None ☐ Mud ☐ Sludge ☐ Debris ☐ Grease
Silt Depth: (in.) Deposits Extent:
Infiltration: **None** Pipe Seal Cond: **Sound**

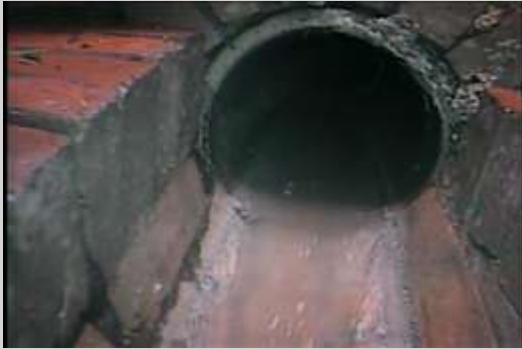
6 O'Clock Inflow

Pipe Height: **8.4** (in.) Rod and Bar (Angled)

Pipe Material: **Clay** ☐ Pipe Lined

Invert Depth: **9.77** (ft.) Flow Characteristics: **Slow**

Deposits: ☒ None ☐ Mud ☐ Sludge ☐ Debris ☐ Grease

Infiltration: **None** Pipe Seal Cond: **Sound**

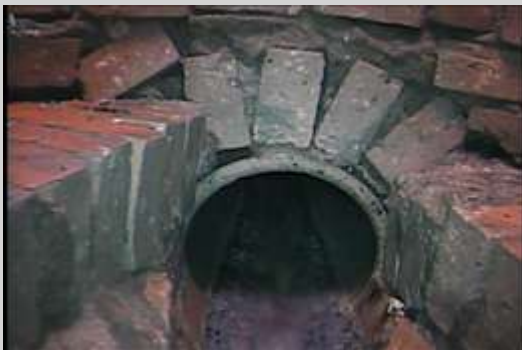
9 O'Clock Inflow

Pipe Height: **8.4** (in.) Rod and Bar (Angled)

Pipe Material: **Clay** ☐ Pipe Lined

Infiltration: **None** Pipe Seal Cond: **Sound**
